Manhole Inspection Summary

Manhole # S05SS1016MH

Inspection ☐ Is Incomplete Rating: **4) Poor**

Location Address: **3518 INGLESIDE AVE**

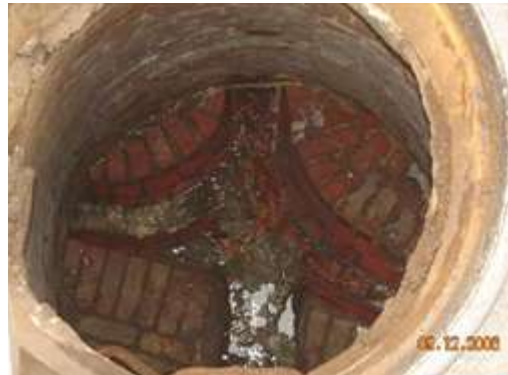
Top View

Frame leaks. Adjustment deterioration and infiltration. Corbel and Barrel infiltration. Evidence of surcharge - Bench

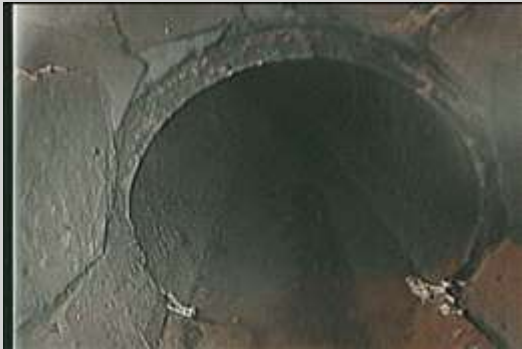
8 in. Circular Gravity Sewer Pipe Out @ 12 O'Clock

Infiltration: **Evidence** Pipe Seal Cond: **Cracked**

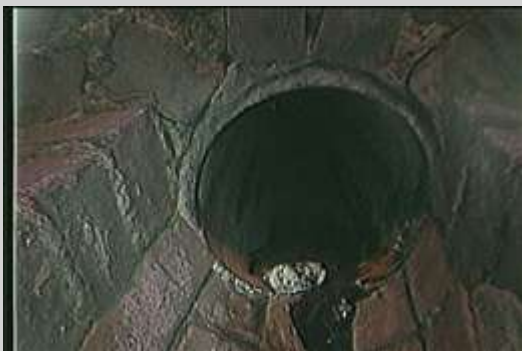
8 in. Circular Gravity Sewer Pipe In @ 3 O'Clock

Channel deterioration.

Infiltration: **Evidence** Pipe Seal Cond: **Unknown**

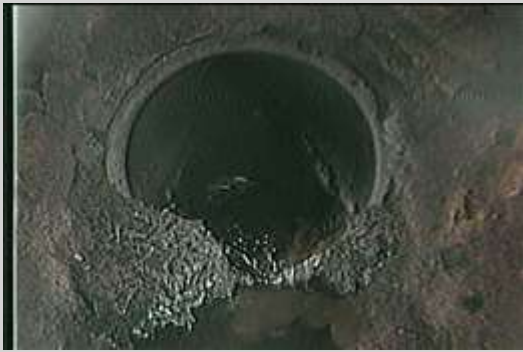
Pipe In @ 6 O'Clock

Channel root intrusion.

Infiltration: **Evidence** Pipe Seal Cond: **Roots**

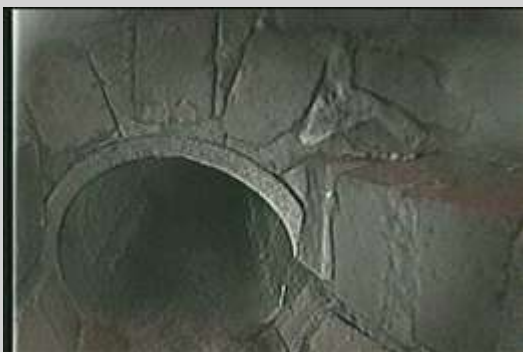
Pipe In @ 9 O'Clock

Barrel deterioration and infiltration.

Infiltration: **Evidence** Pipe Seal Cond: **Unknown**
